Seismic Instrumentation of Healthcare Facilities

A White Paper on the Usefulness and Benefits of Seismic Instrumentation of Healthcare Facilities

By the
Hospital Building Safety Board
Instrumentation Committee

2022

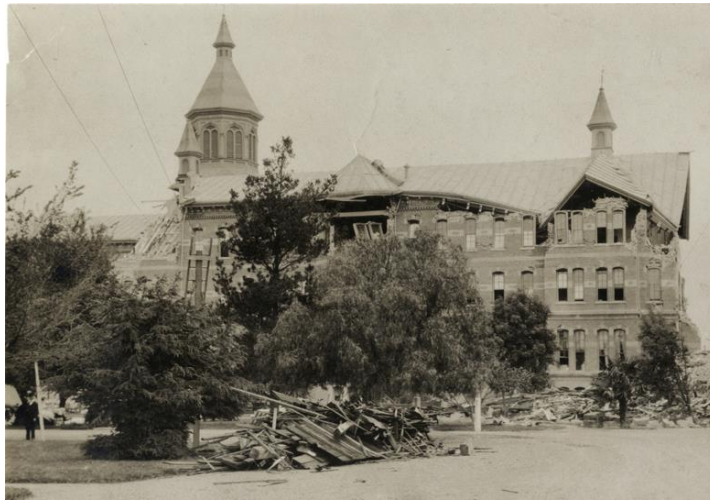
Figure 1. Damage to the San Jose Agnew Mental institution during the 1906 San Francisco earthquake¹

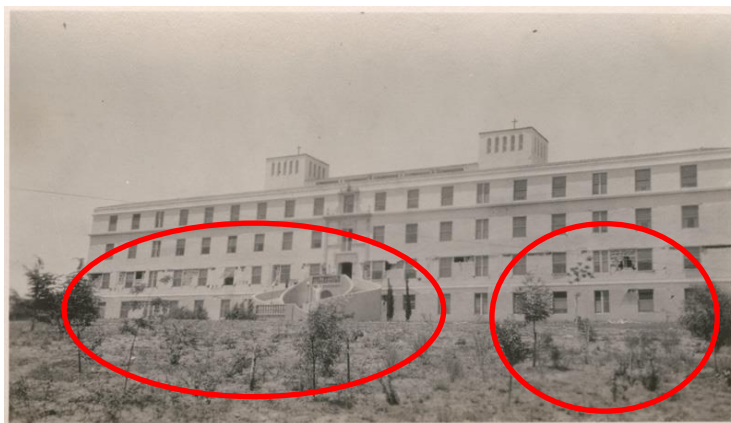
Figure 2. Damage to the Santa Barbara St. Francis hospital during the 1925 Santa Barbara earthquake²

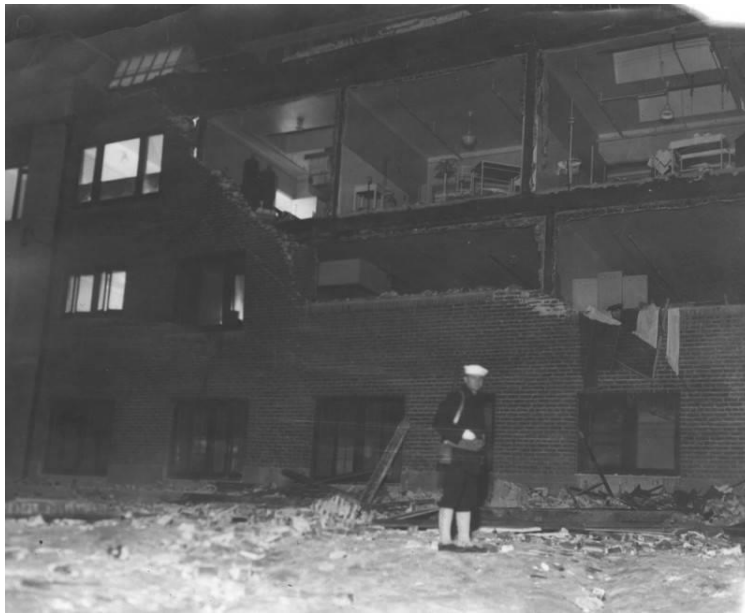
Figure 3. Damage to the Seaside Hospital during the 1933 Long Beach earthquake³

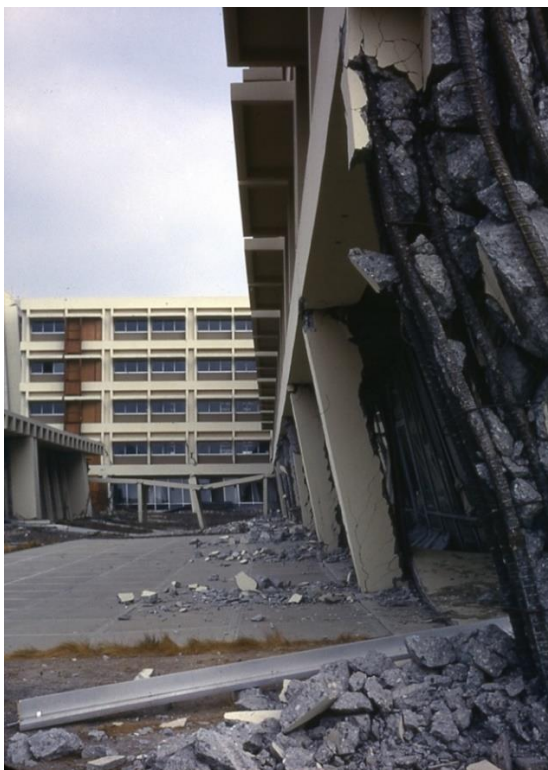
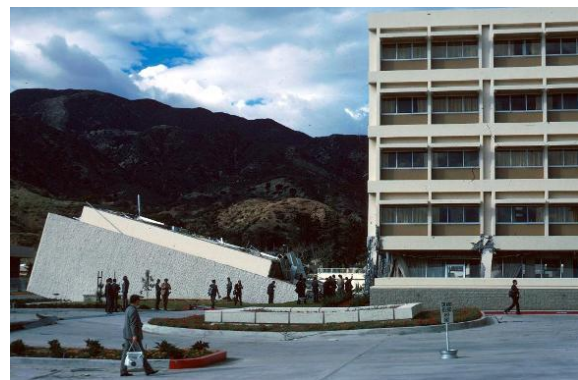
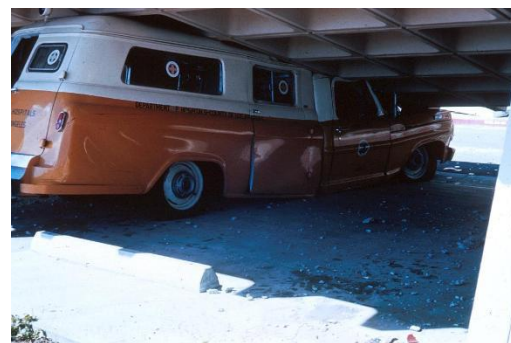
Figure 4. Damage to the original Olive View Hospital during the 1971 San Fernando earthquake⁴; this facility was demolished and replaced by a new hospital building.

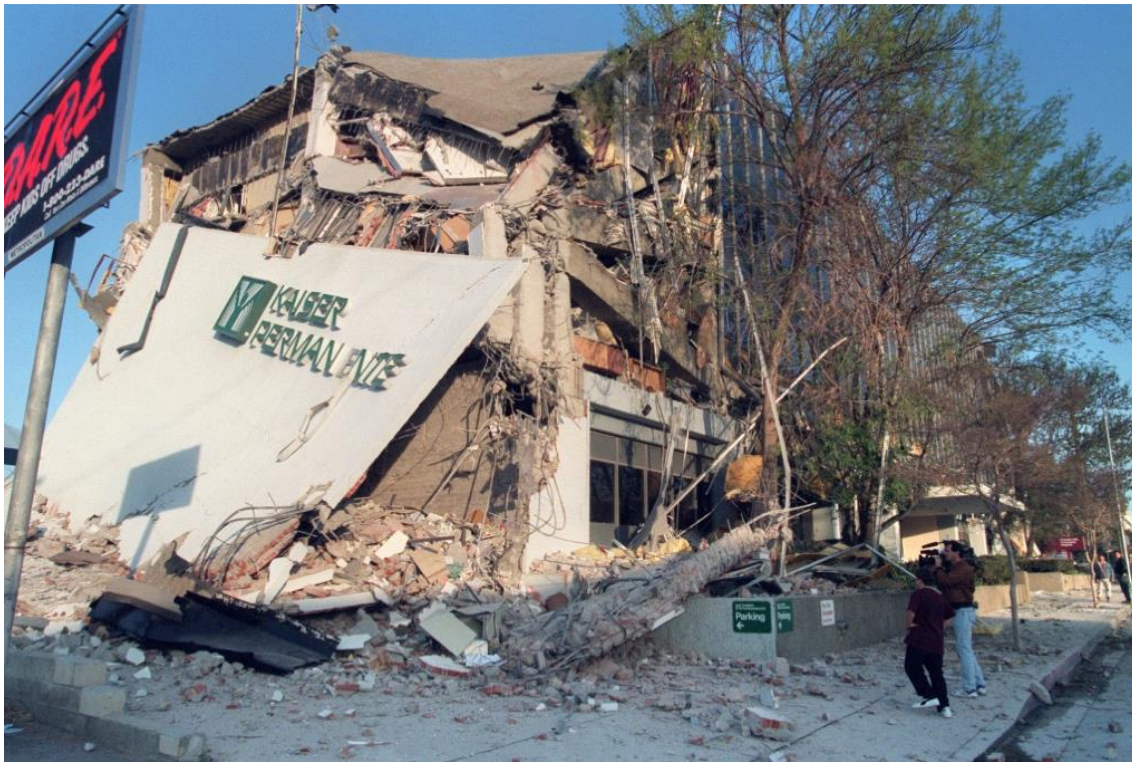
Figure 5. Damage to the Kaiser Permanente clinic building in Granada Hills during the 1994 Northridge earthquake⁵

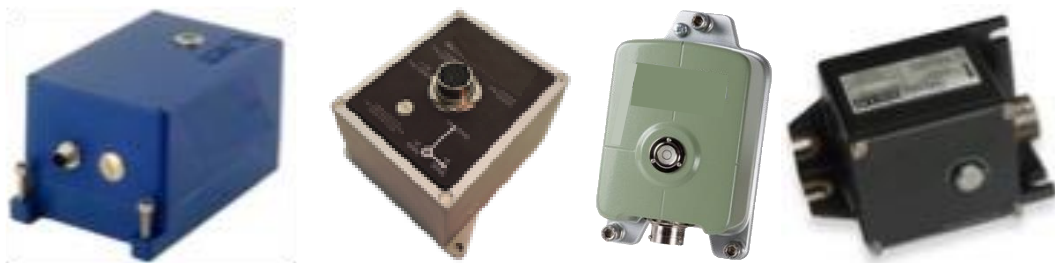
(a) examples of sensors to measure accelerations

Figure 6. Sensors that have been and can be installed at hospitals for seismic instrumentation and structural health monitoring.

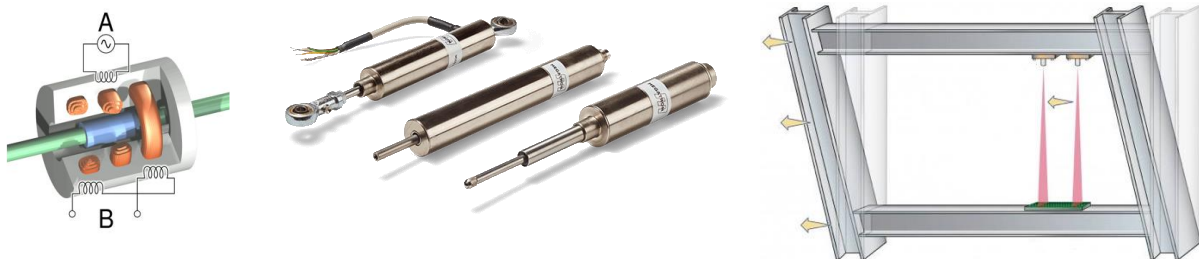
(b) examples of sensors which can be used to directly measure displacements

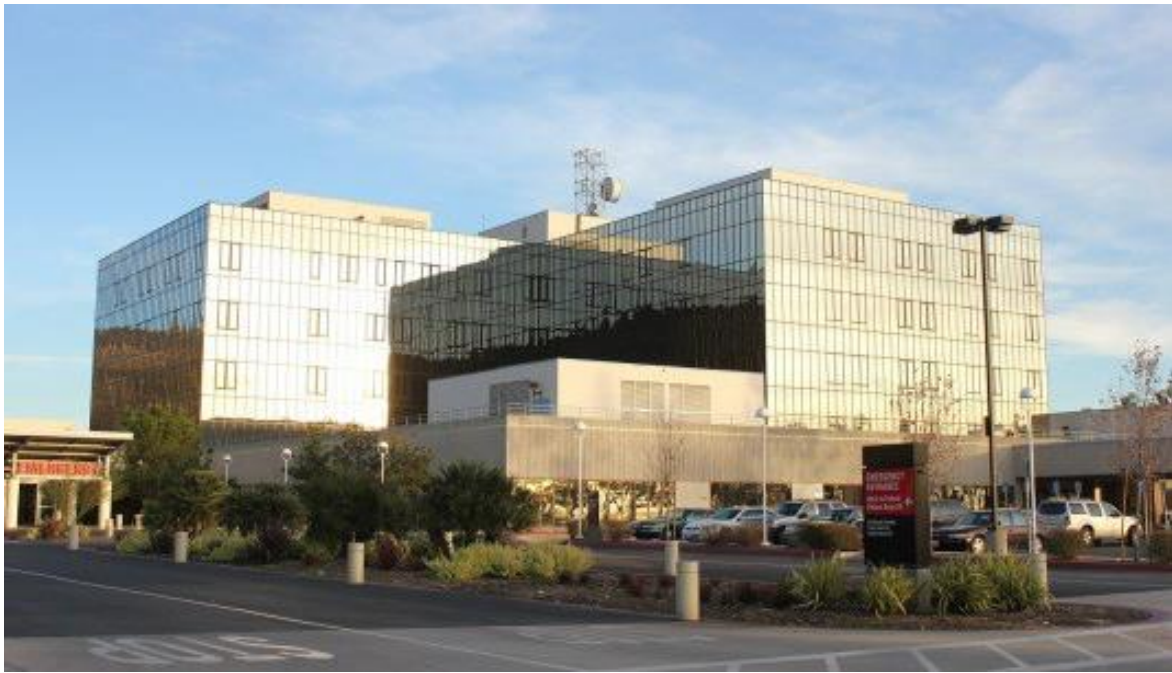
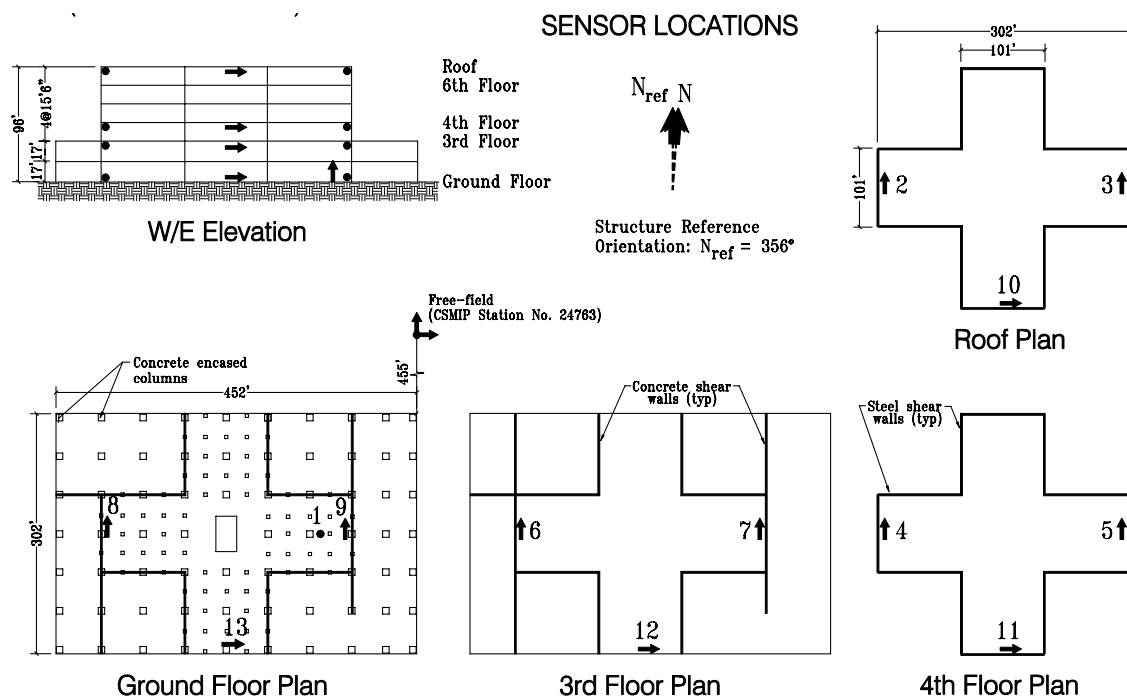
Figure 7. Photo (top) and sensor lay out diagram (bottom) of the six-story Olive View-UCLA Medical Center (New Sylmar County Hospital). Arrows in the schematic diagram show the locations and indicate the directional sensitivity of the strong-motion sensors (accelerometers). The sensors are connected to a central data acquisition system in the building⁶.

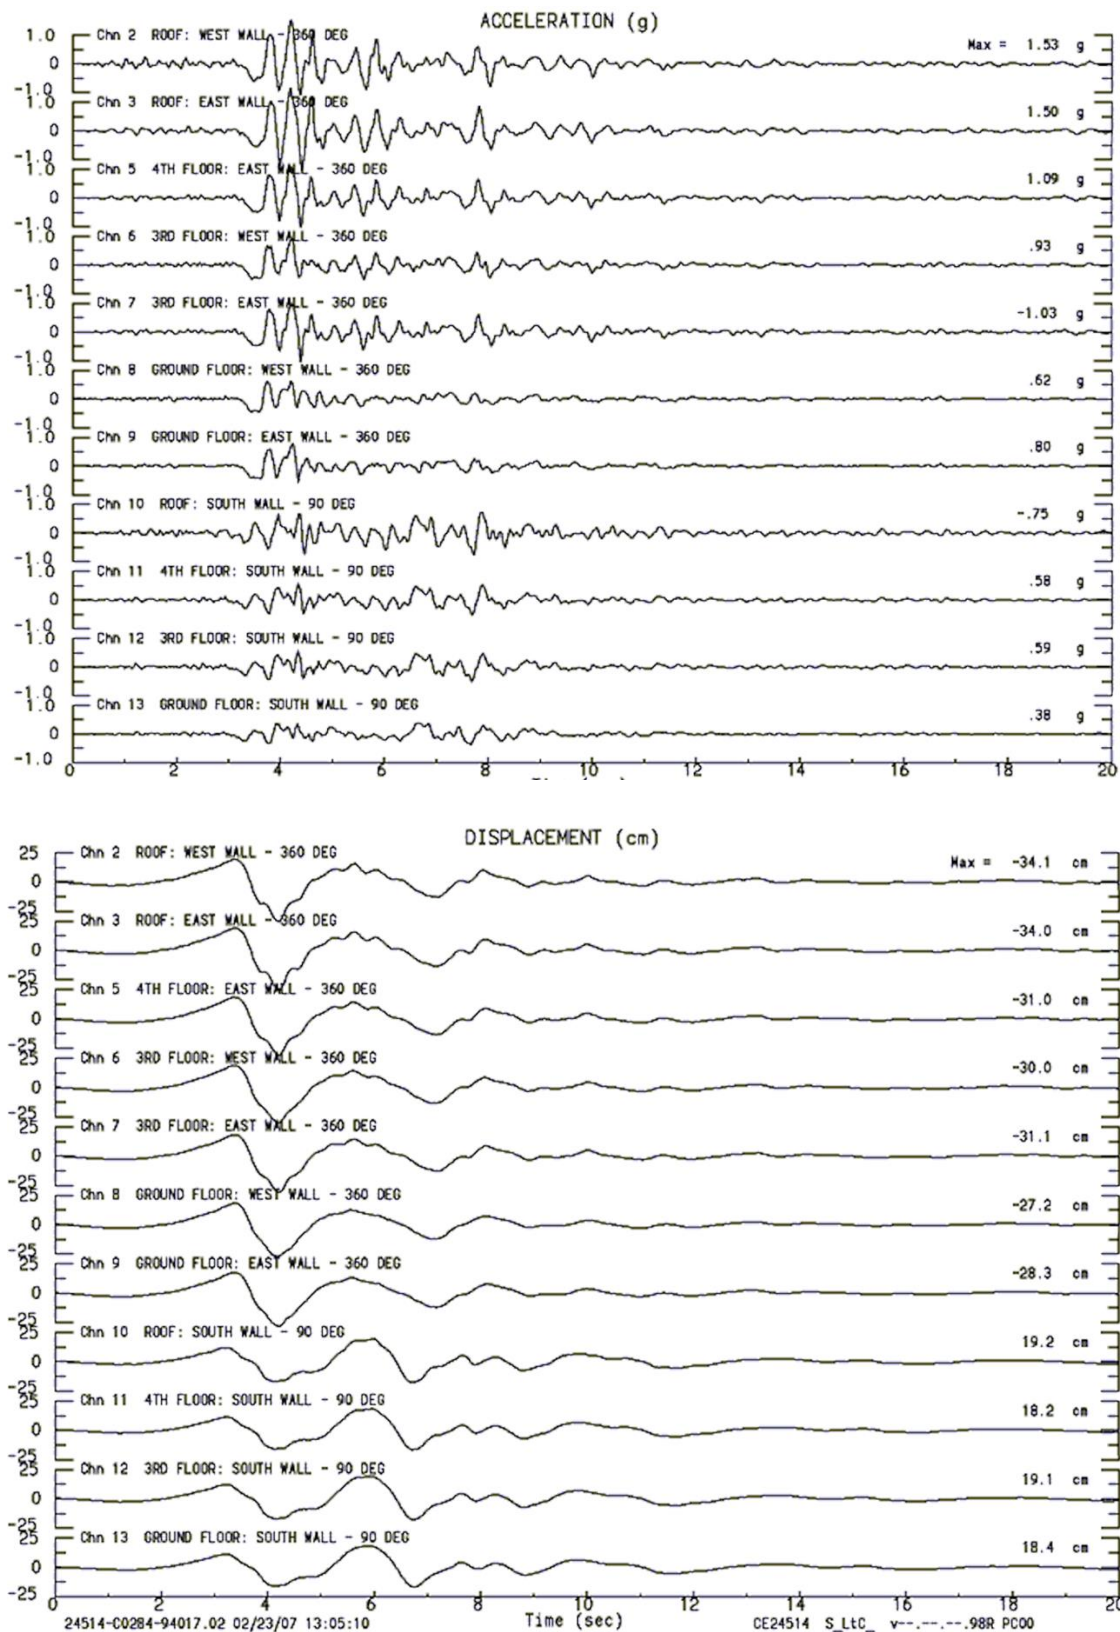
Figure 8. Structural responses (accelerations at the top and displacements at the bottom) recorded by seismic instrumentation system installed at the new Sylmar County Hospital during the 1994 Northridge earthquake⁶.

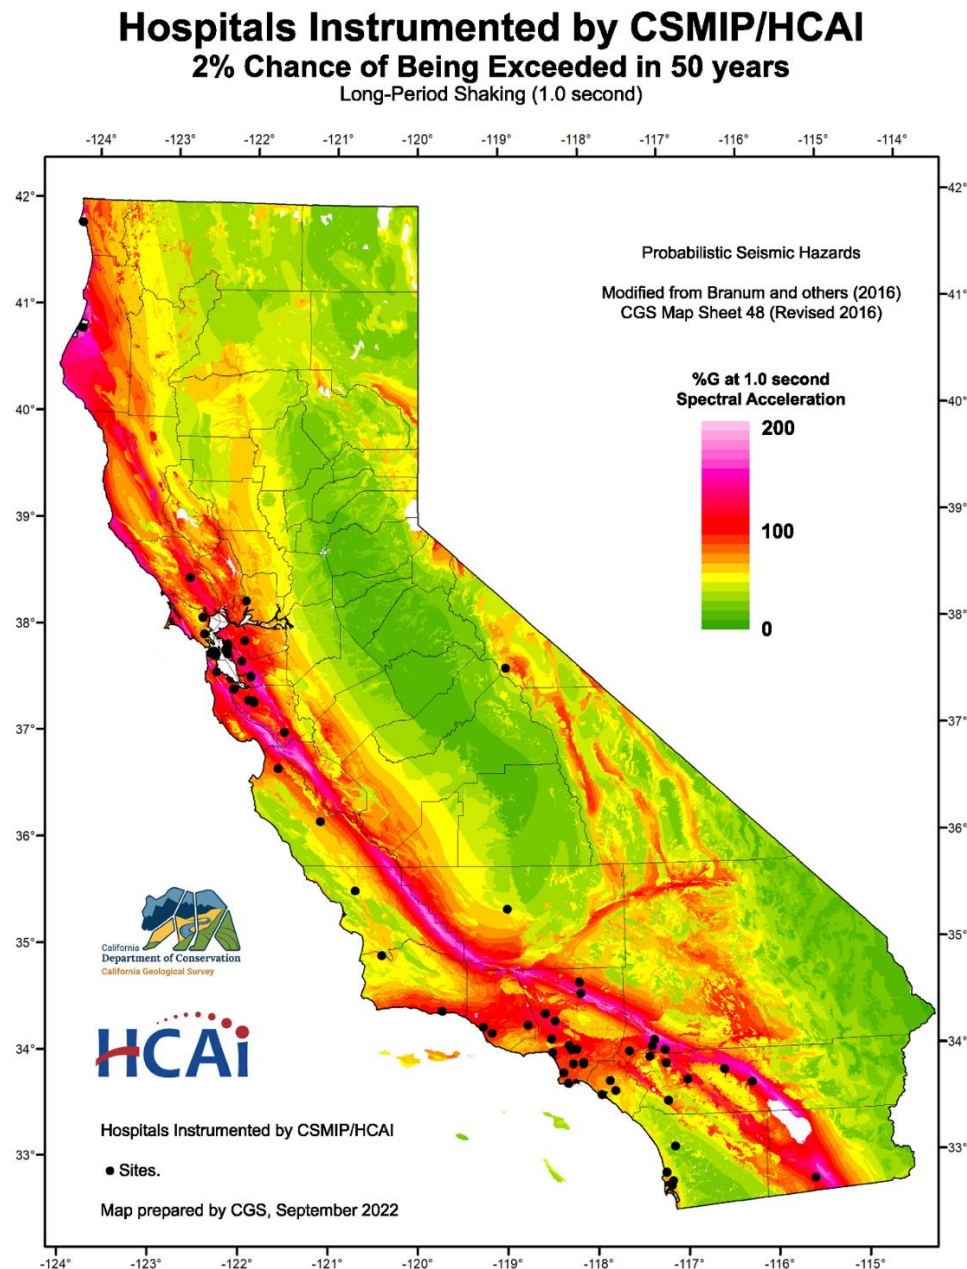
Figure 9. Locations of the instrumented hospital buildings (black dots). The base map is the seismic hazard map of the California. Colors on this map display the levels of horizontal shaking that have a 2 percent probability of exceedance in a 50-year period.

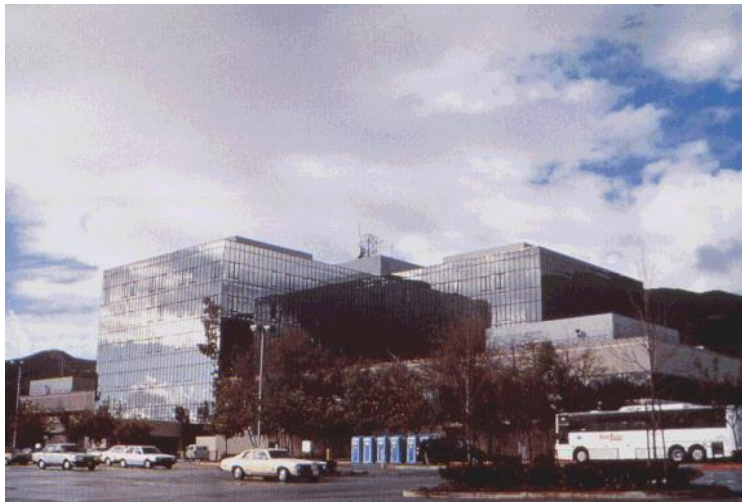
Figure 10. An outside view of the new Sylmar County Hospital Building (now Olive View-UCLA Medical Center) the day after the 1994 Northridge earthquake.¹⁰

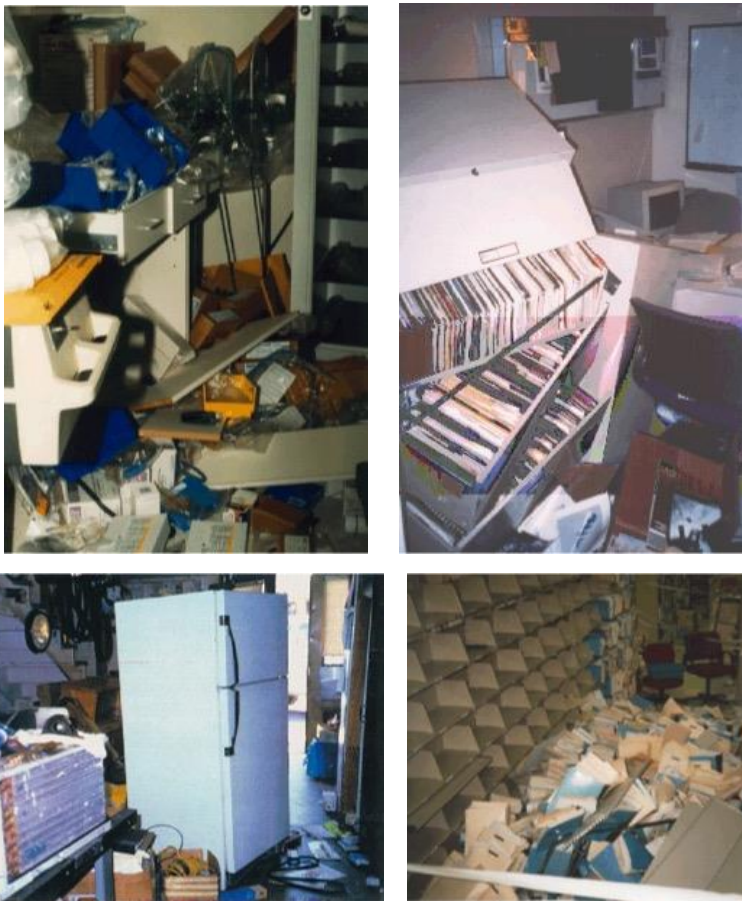
Figure 11. Examples of nonstructural damage at the new Sylmar County Hospital during the 1994 Northridge earthquake¹⁰.

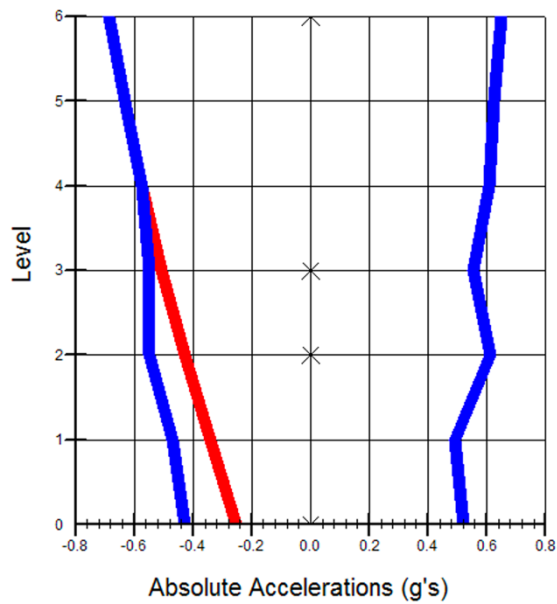
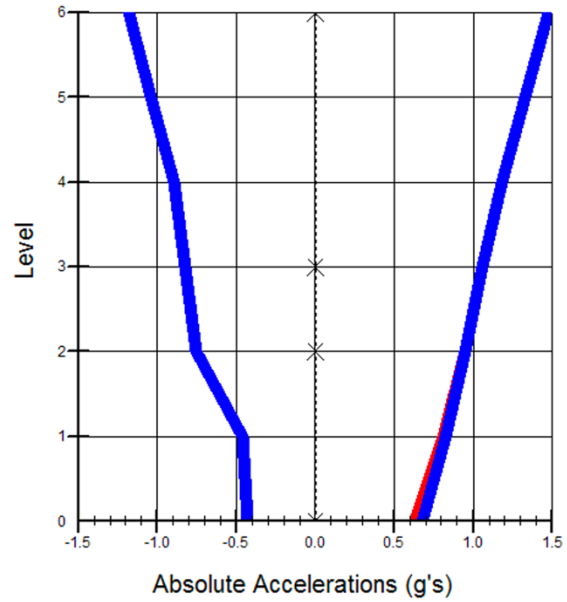
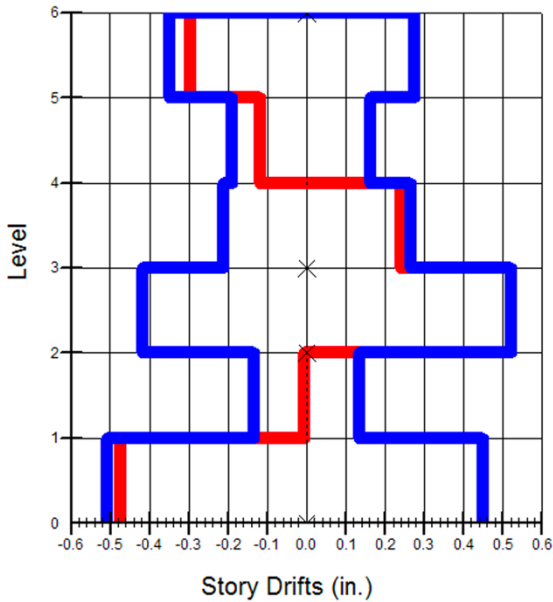
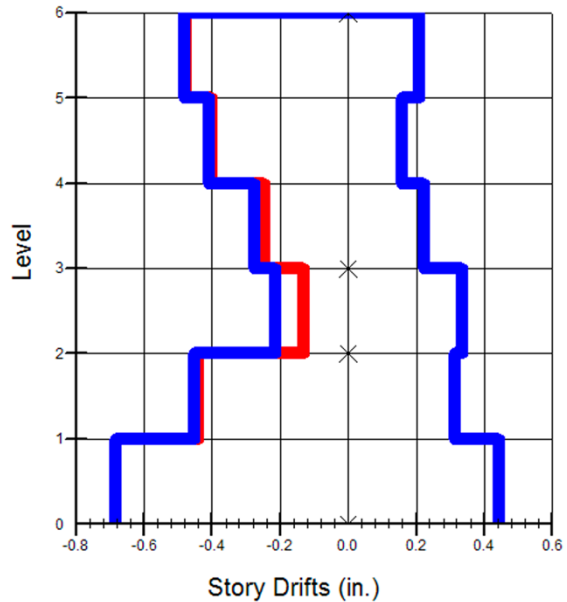
(a) Envelope of E-W floor accelerations
(the maximum occurs at 7.72 seconds
indicated by red line)

(b) Envelope of N-S floor accelerations
(the maximum occurs at 4.22 seconds
indicated by red line)

(c) Envelope of E-W story drifts
(the maximum occurs at 6.78 seconds
indicated by red line)

(d) Envelope of N-S story drifts
(the maximum occurs at 4.24 seconds
indicated by red line)

Figure 12. Structural response quantities interpreted from the sensors installed at the new Sylmar County Hospital for the 1994 Northridge earthquake¹⁰.

With the technology available in 1994, the recordings from the seismic instrumentation required collection and processing which was some weeks and months after the earthquake. The analysis of the data would take more time also. The maximum floor accelerations and story drifts interpreted from the instrumentation data are presented in Figure 12.

If the data summarized in Figure 12 were available immediately after the earthquake and the instrumentation system were connected to a simple application on a computer or a cell phone or tablet application, the data could be processed as shown in Figure 12. The processed data can be passed through some very basic fragility functions (that predict damage), such as those embedded in HAZUS-MH¹¹ or FEMA P-58¹² documents, then an estimate of the status of the building's structural and nonstructural performance would have been almost immediately available as shown in Figures 13 to 16.

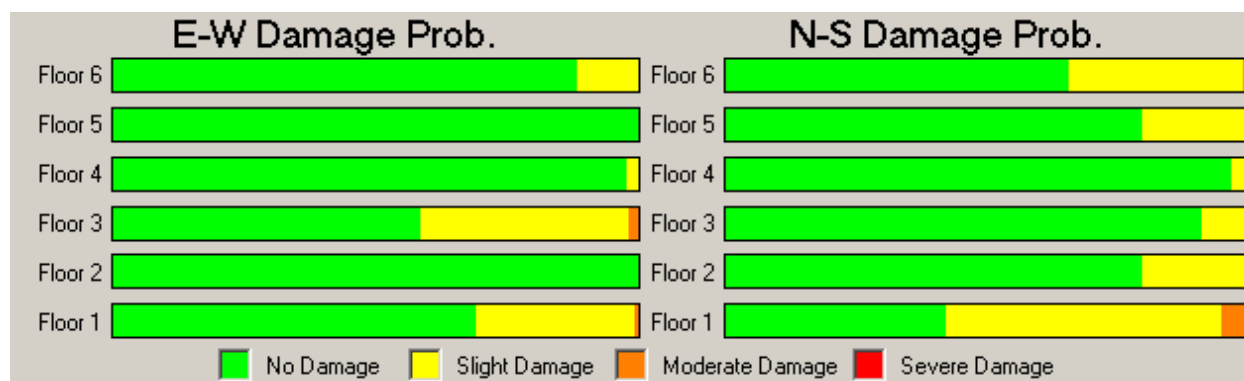
Figure 13. Instrumentation indicates no damage to slight damage status of the Sylmar County Hospital structural system following the 1994 Northridge earthquake using a relevant and readily available HAZUS-MH fragility function¹³.

As illustrated in Figures 13 through 16, simple fragility functions which were not specifically developed for hospital buildings were able to confirm the observations of both structural and nonstructural performance of the Sylmar County Hospital in the 1994 Northridge earthquake. Therefore, utilization of newer and building-specific fragility functions and methodologies can result in even more accurate evaluation of the status of the structural and nonstructural systems and components of a properly instrumented hospital building during or rapidly after an earthquake.

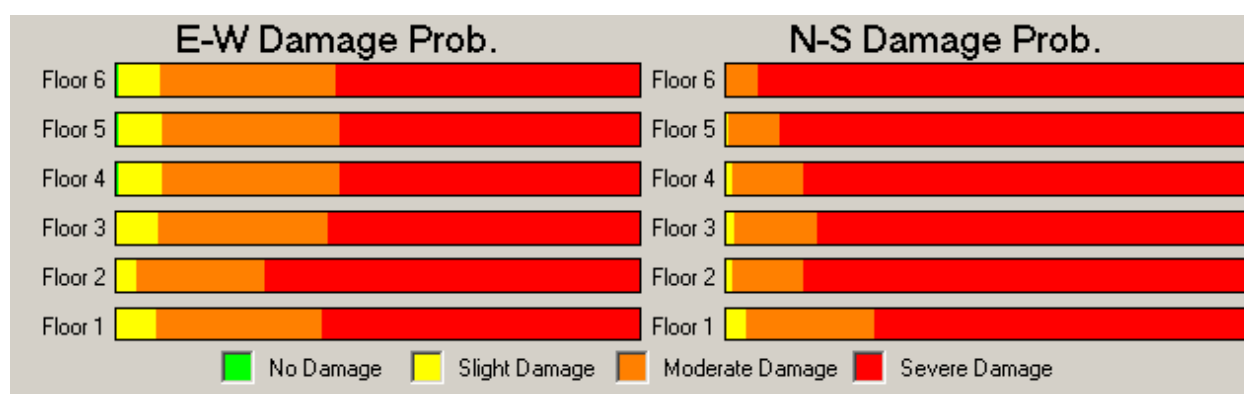
Figure 14. Instrumentation indicates moderate to severe damage status for the nonstructural systems of the new Sylmar County Hospital following the 1994 Northridge earthquake using a relevant and readily available HAZUS-MH fragility function¹³.

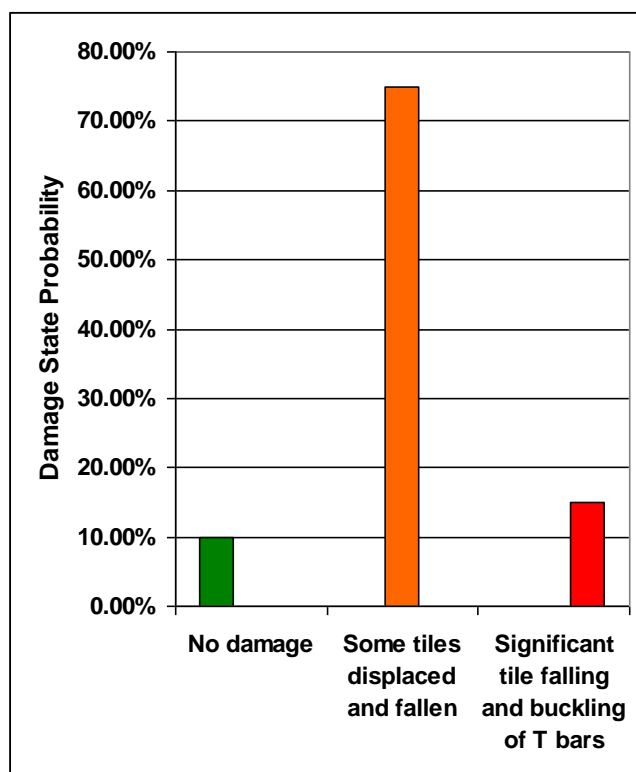
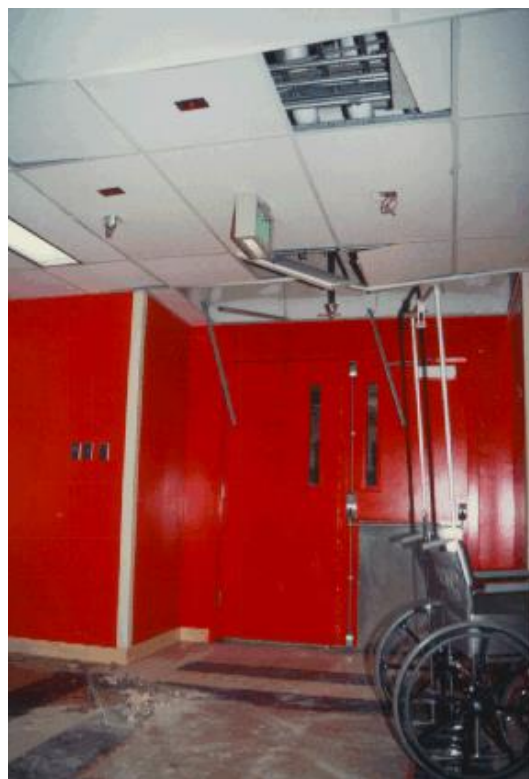
Figure 15. Instrumentation indicates displaced suspended ceiling tiles on the first floor of the new Sylmar County Hospital following the 1994 Northridge earthquake using a relevant and readily available FEMA-P58 fragility function¹³.

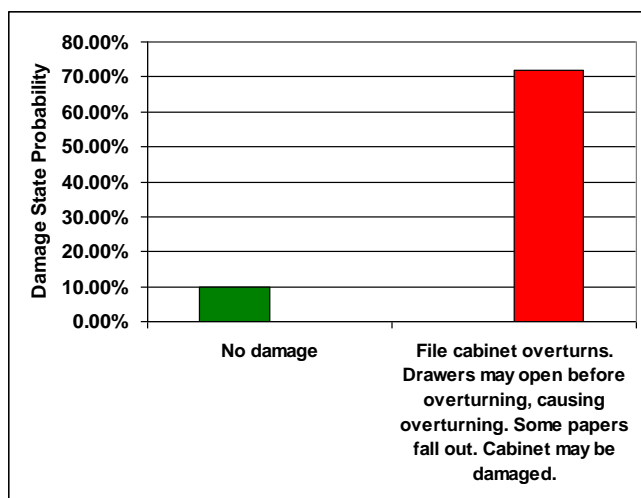
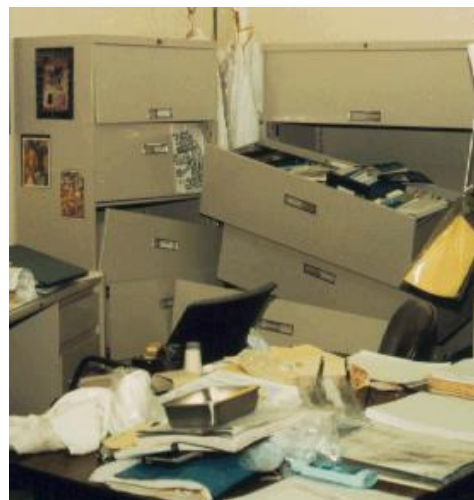
Figure 16. Instrumentation indicates overturning of file cabinets on the 6th floor of the new Sylmar County Hospital following the 1994 Northridge earthquake using a relevant and readily available FEMA-P58 fragility function¹³.

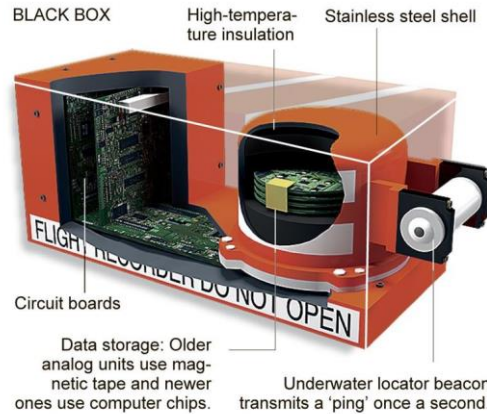
Commercial aircraft are required to carry two data recorders. One records all radio transmissions and sounds in the cockpit and the other monitors parameters of the flight such as airspeed and altitude – all vital in reconstructing an accident.

**Figure 17. The concept of “black boxes” for buildings
(Courtesy of Talhan Biro)¹³.**

There needs to be a shift from simple instrumentation to a concept like that of a “Black Box” which is implemented in airplanes and cars (Figure 17). The “black box” could be a physical recorder located in the building or a virtual one in the Internet cloud. If the building “black box” is functional for an instrumented building at the time of an earthquake, the data from sensors are processed by the black box and results will be made available almost instantaneously. After the event, the data are transmitted to a central data center where it is received and processed and then posted to local data centers, followed by notification of the facility contact for some facilities. All the functions of data retrieval, data processing, and notification could be done on-site, very rapidly, with timely notification to key people. The black box would retain all the data from the sensors and the calculated motions and responses.

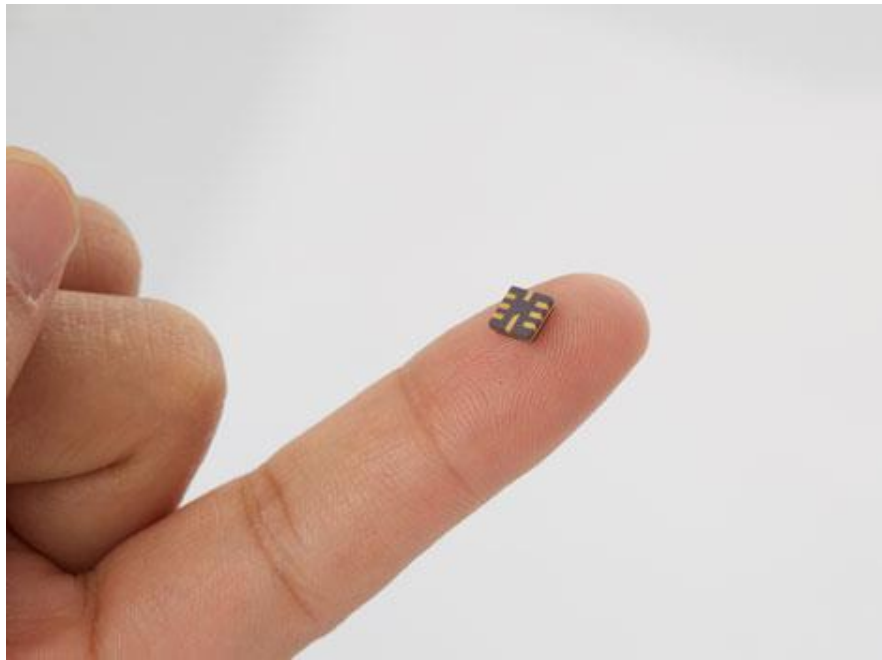
Figure 18. A typical MEMS sensor which can be used to measure acceleration, tilt, pressure, and humidity. Many of these sensors are installed in every modern cell phone in use today¹⁵.

Lower cost and lower resolution sensors such as Class C MEMS¹⁴ (micro-electromagnetic systems) accelerometer sensors (Figure 18) are becoming widely available and could be one of the sensor types that could help more widespread instrumentation of hospital buildings for the post-earthquake safety assessment purposes. Site and building specific real time data that would be highly valuable in the post-earthquake response environment. Other technologies such as the USGS ShakeAlert Earthquake Early Warning System, Community Seismic Network (Figure 19), displacement and velocity measurement devices (Figure 6), airborne and spaceborne remote sensing devices, and artificial intelligence based tools for damage assessment (Figure 20) are all potential tools that could be implemented in hospital facilities now or in the future, once they have been studied and their ranges of accurate response and limitations are clearly established, to assist with post-earthquake status evaluation of hospital buildings.

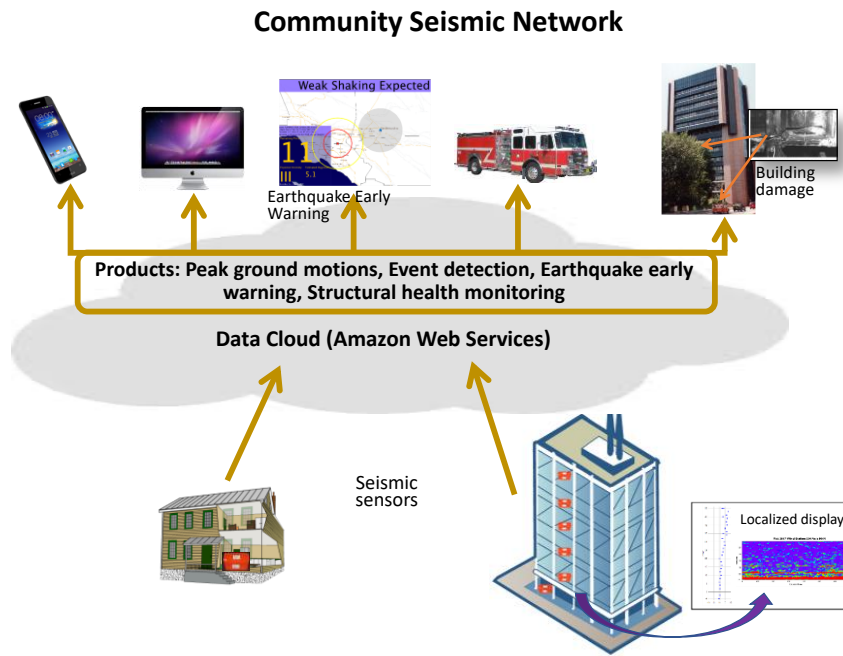
Figure 19. The Community Seismic Network implemented and managed by California Institute of Technology and UCLA provides a low-cost alternative for instrumentation of school campuses and other buildings with limited budget for instrumentation.¹⁶

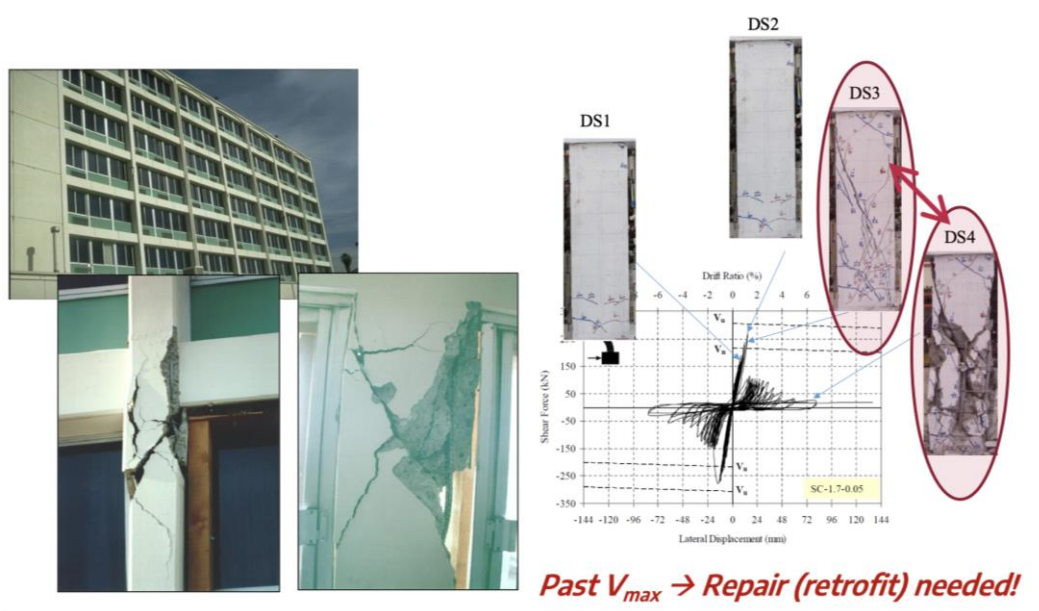
Figure 20. Integrating artificial intelligence, machine learning, and photographic tools creates yet another opportunity for immediate post-earthquake assessment of buildings as demonstrated by the ATC-145 project currently underway and sponsored jointly by FEMA and the New Zealand Earthquake Commission¹⁷.
